Thames River Walls Coring Tests

Client: Thames Tideway

Location: London

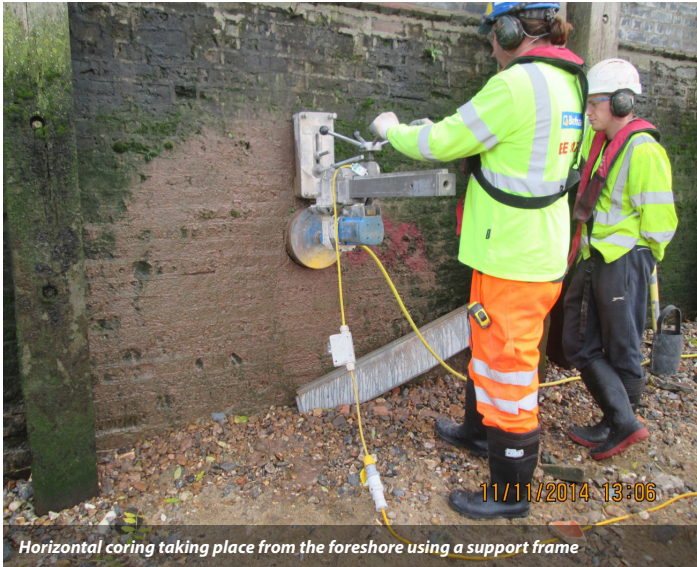
Horizontal coring taking place from the foreshore using a support frame

Due to the terrain of the foreshore the coring rig could not be used for the horizontal coring since it was highly likely the rig would sink in the wet ground. Instead, the team used a hand portable, 110v electric drill held steady by a supporting frame that was bolted to the face of the river wall.

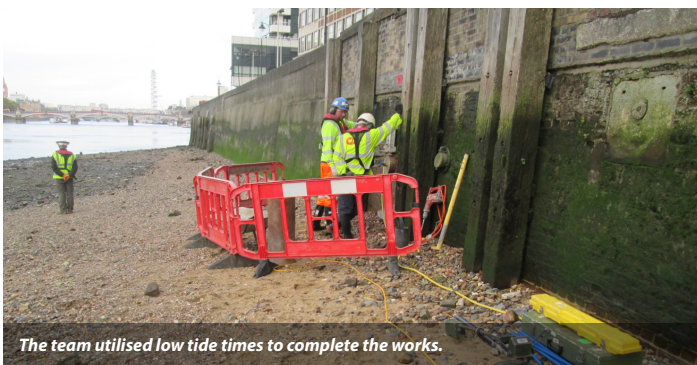
The team utilised low tide times to complete the works.

The horizontal cores were required at only 1m above the river foreshore level, which meant the team had to plan working in tidal conditions and complete the work at each location in a single tide cycle. To mitigate the risk of the works not being completed before the tidal levels rose, the team kept approved double bungs on hand to plug the voids if necessary. Once the cores were extracted, the voids were reinstated using approved quick set epoxy mortar and the brick face was reinstated using similar facing brickwork.

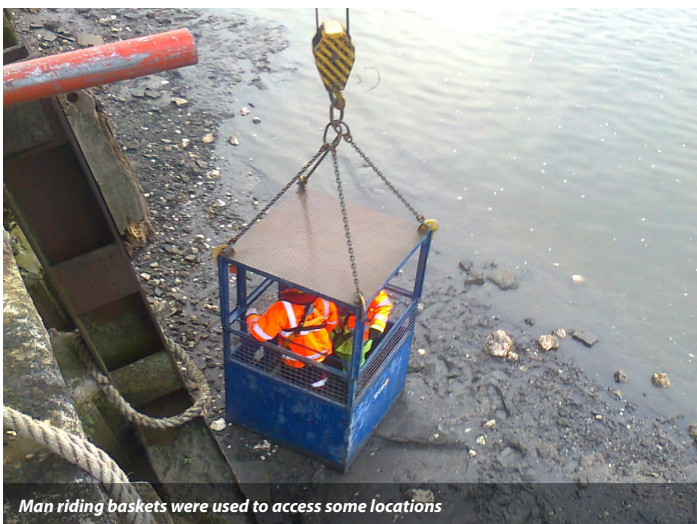
Man riding baskets were used to access some locations

Where the foreshore was inaccessible by foot, the team positioned an 8t crawler crane above the required work location and lowered 2 operatives and the equipment in a man-riding basket along the face of the wall. Once in position the man-riding basket was secured to the wall face using anchor bolts to prevent any movement of the basket during the coring activities.
